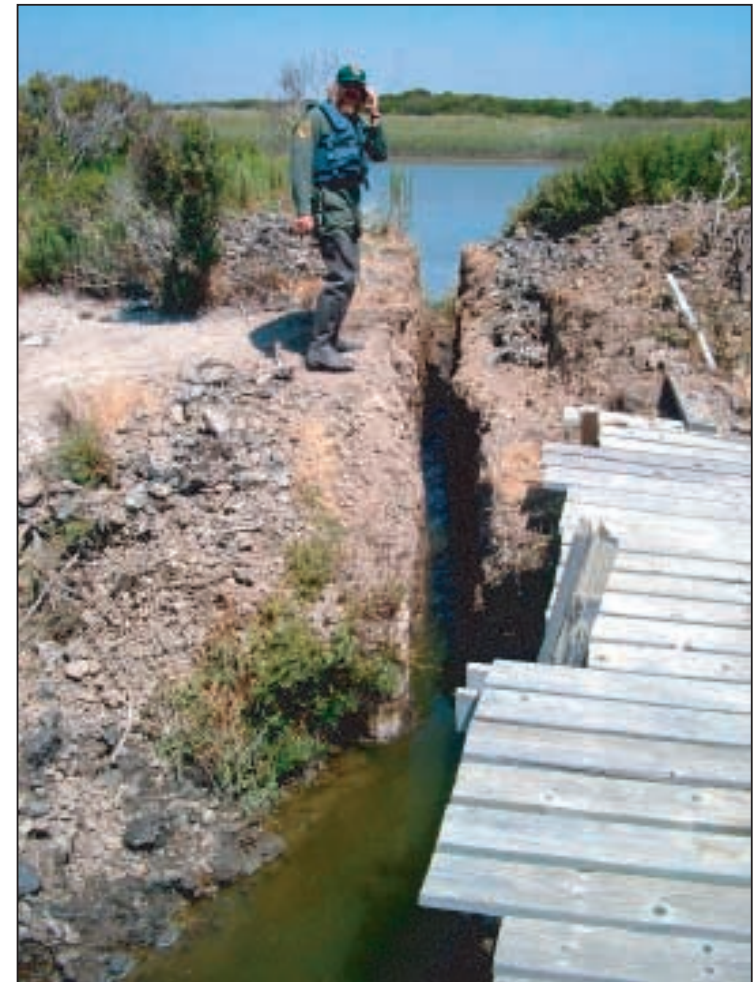
In August 2002, an unknown party dug a small 2-foot wide ditch between Pond 3 and South Slough (D1). DFG subsequently obtained an emergency exemption to create a small 2-foot-wide ditch on the southeast side of Pond 3 to facilitate better circulation of water in and out of Pond 3 (D2). The initial ditch was not repaired because of the cost of filling in the ditch and because the pond may be breached in the future. If adverse water quality effects are detected, the ditches will be repaired.

Photo of D1 (August 2002)
