**Comparison of Flows in Napa River
and through Breach in Pond 4**

PWA #: 1174-8

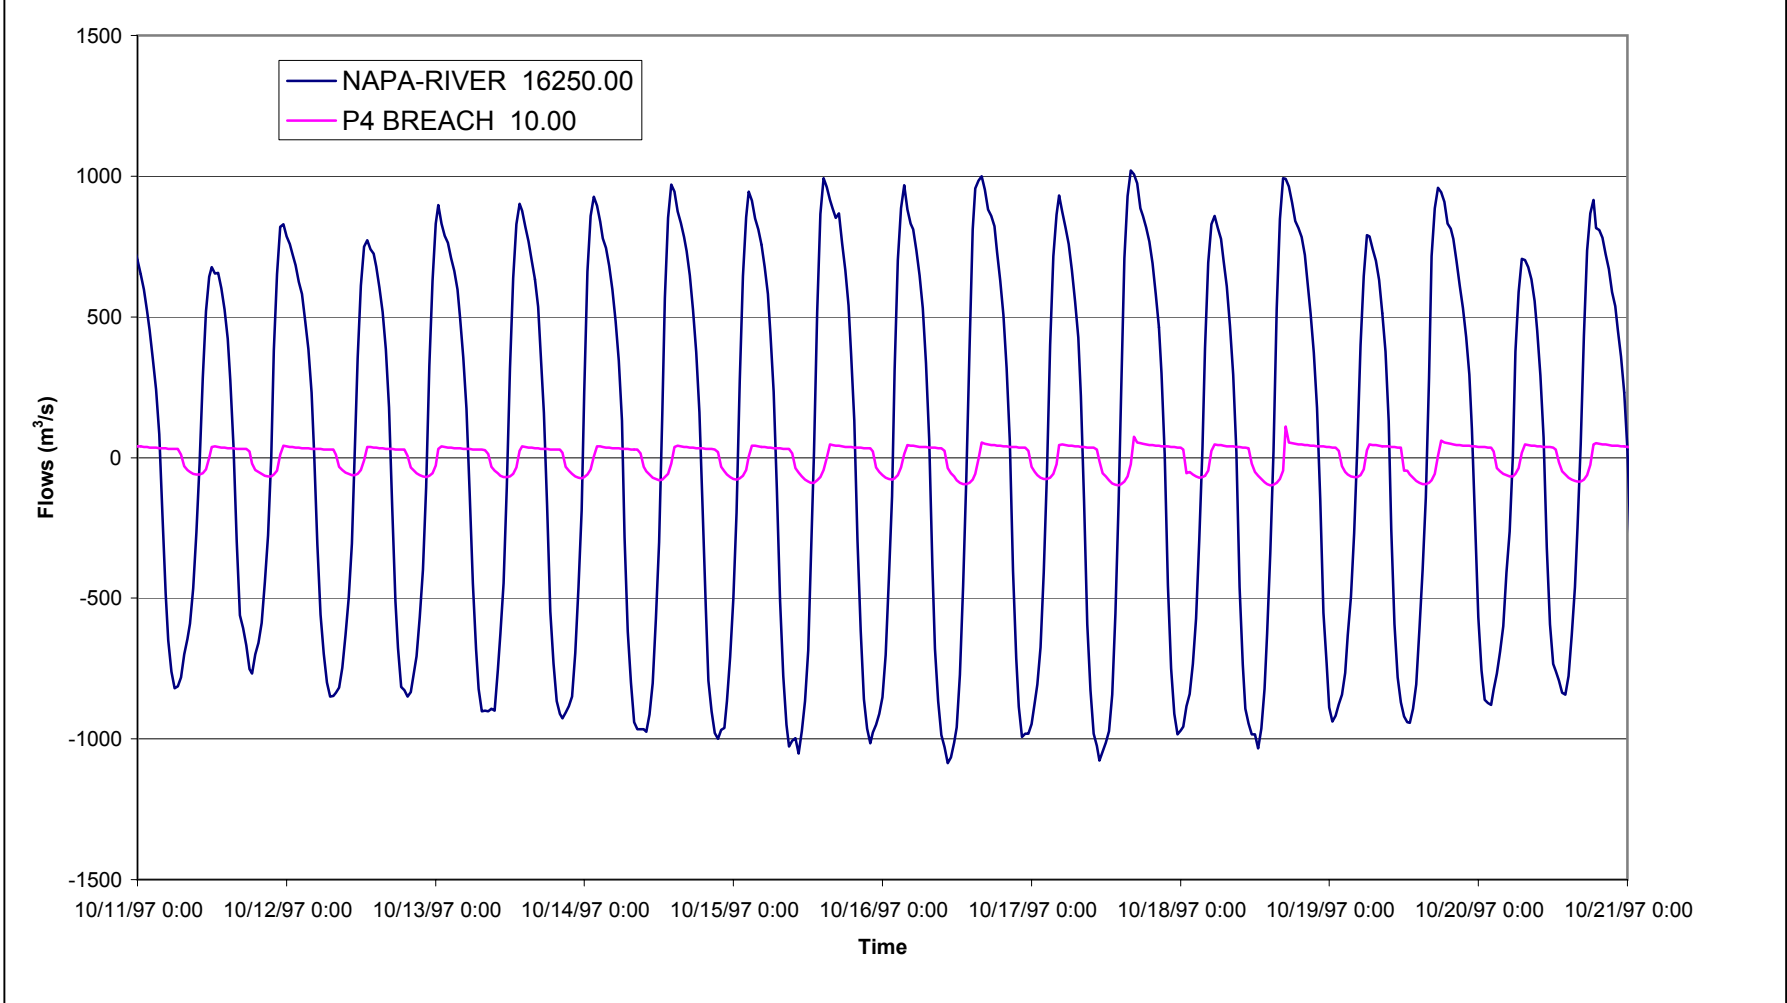
figure 8-2

**Comparison of Flows in Napa River
and through Breach in Pond 4 (Closer Details)**

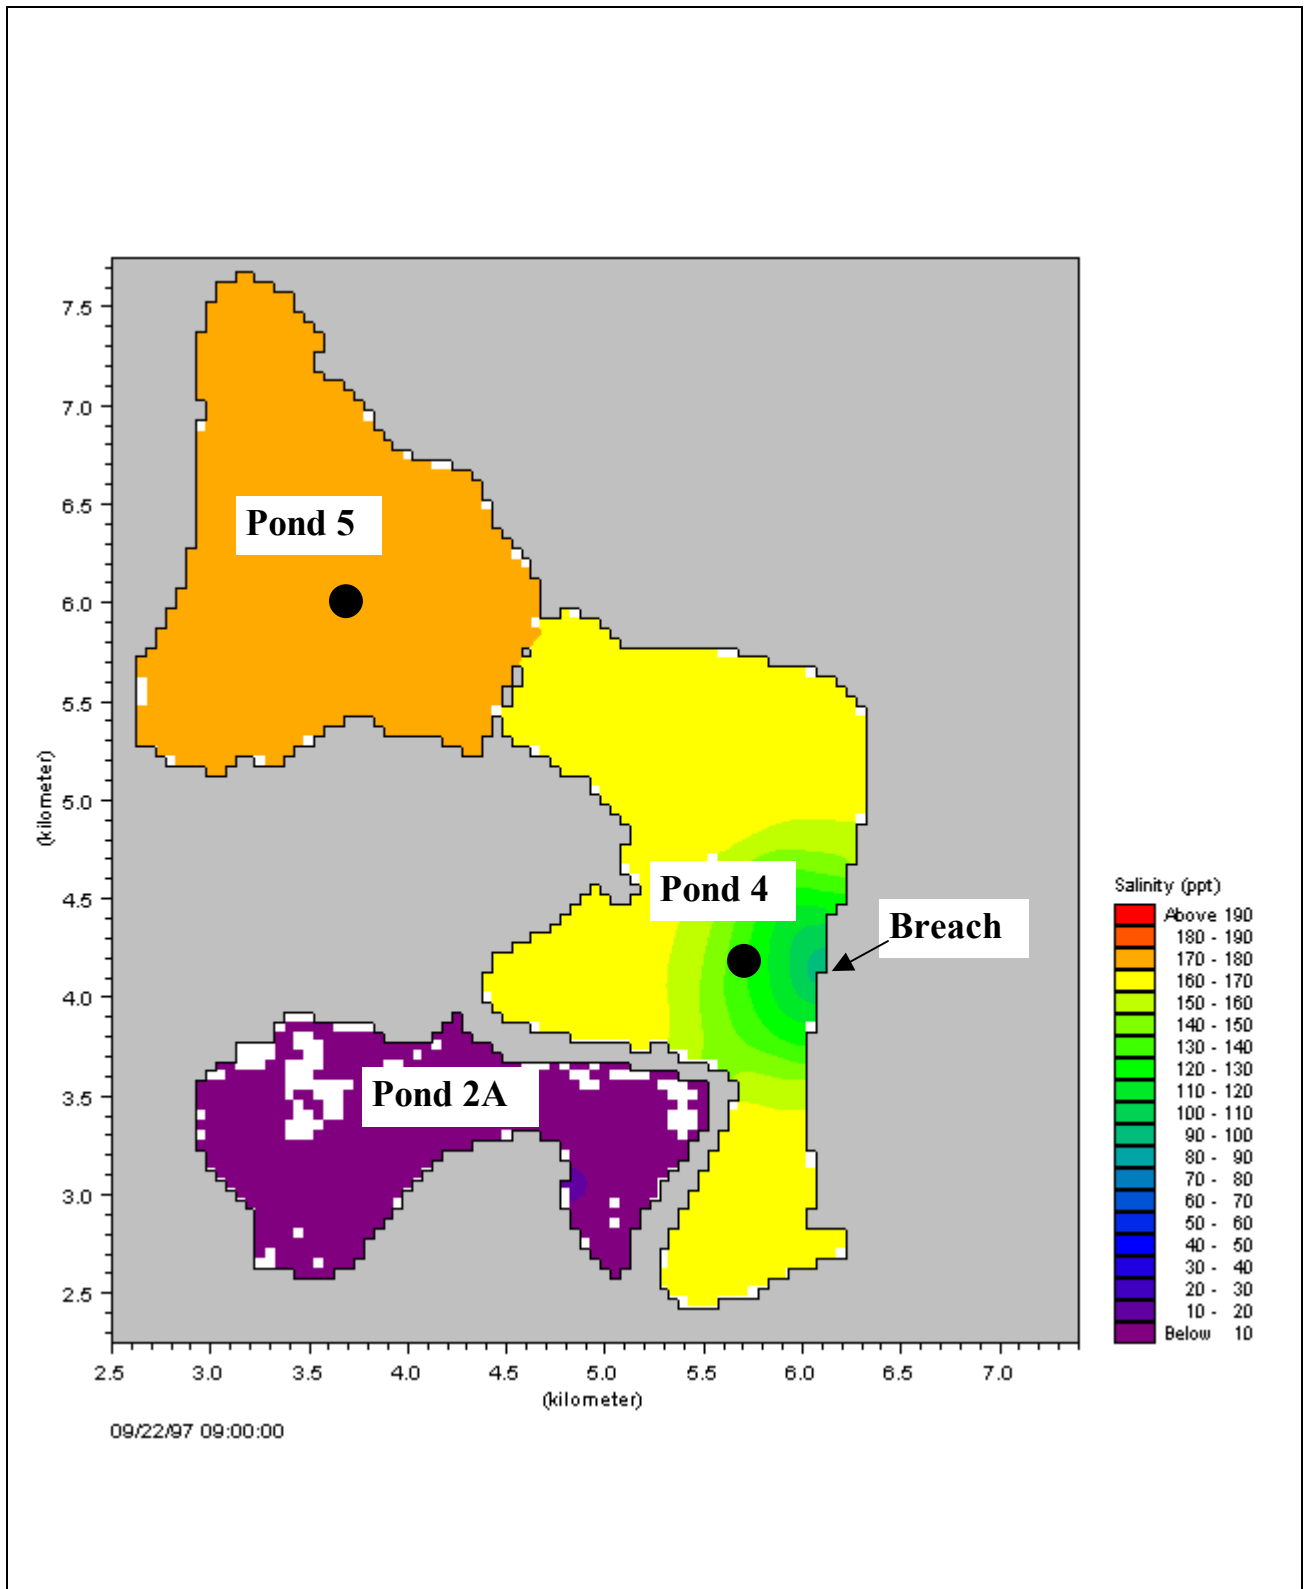
figure 8-3

Notes: Outgoing Tide

**Salinity Post Pond 4 Breach:
6 Hours Later**

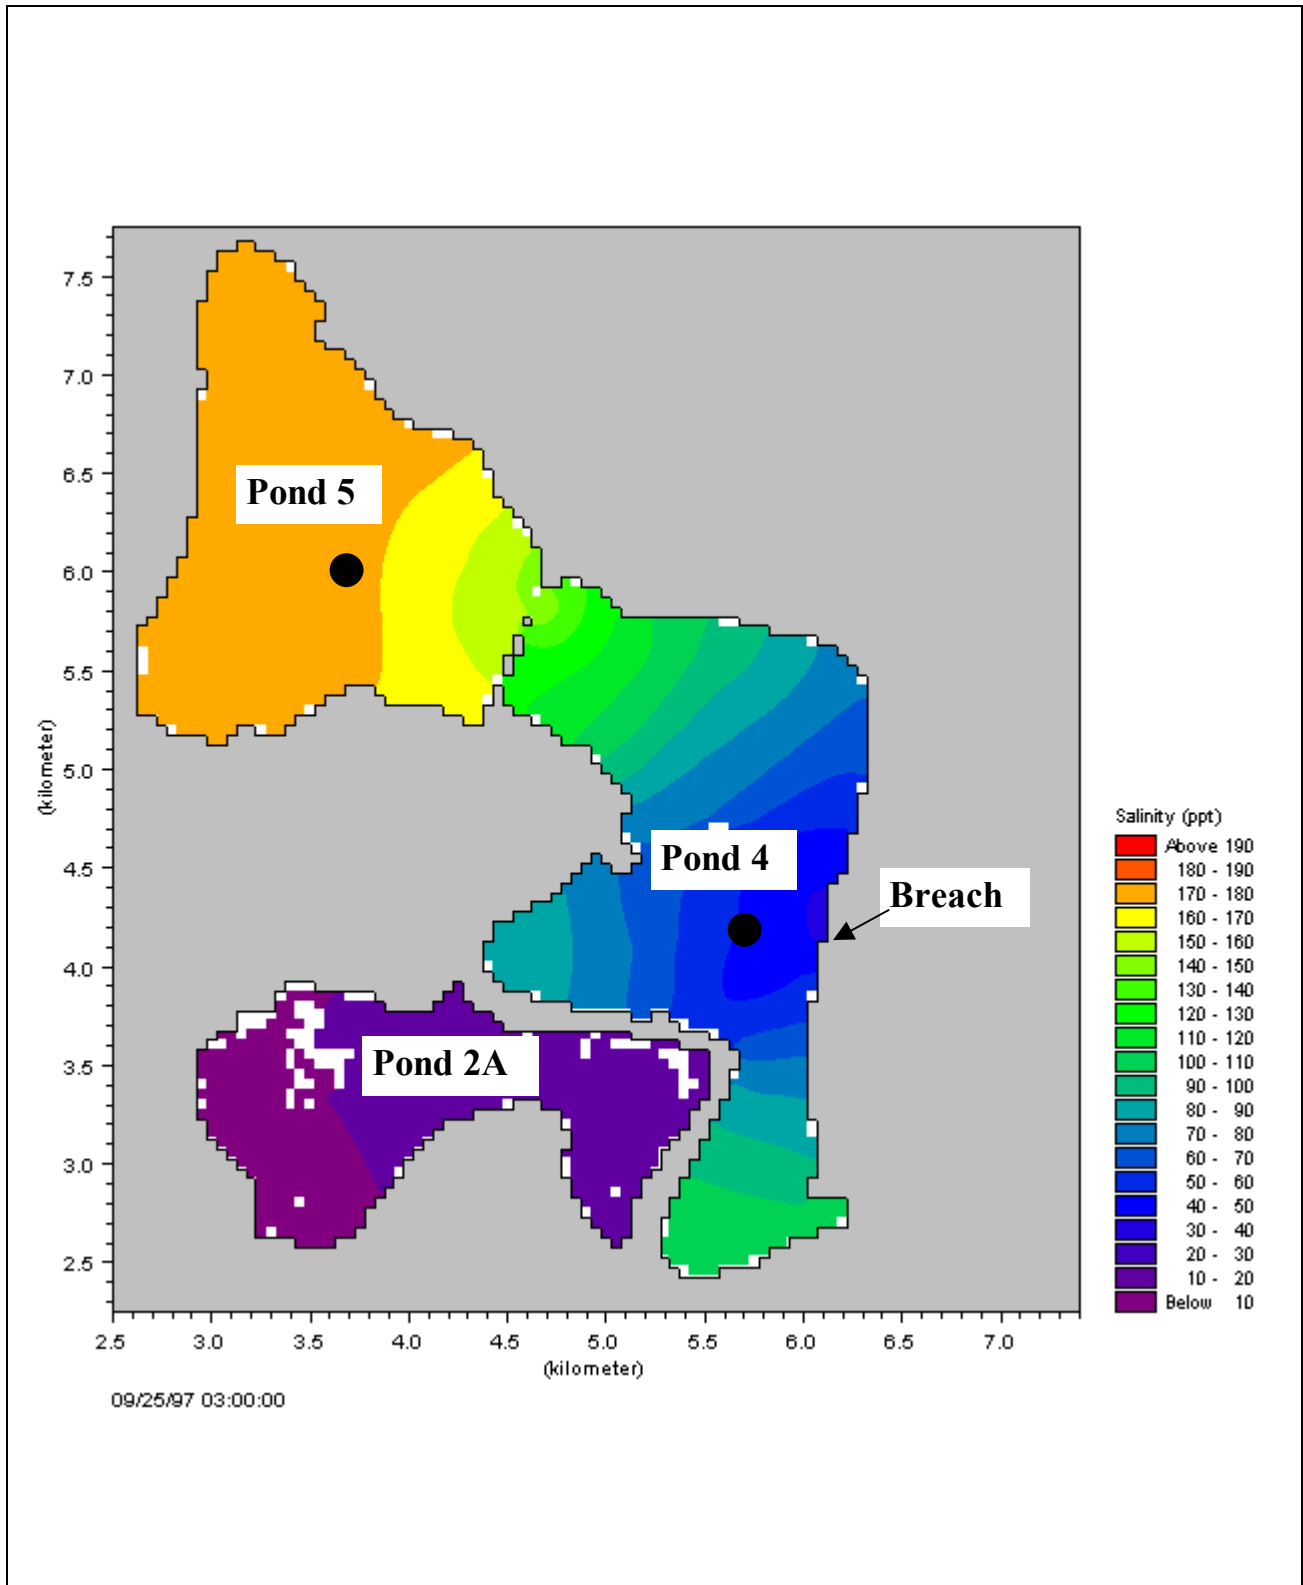
figure 8-4

Notes: Outgoing Tide

**Salinity Post Pond 4 Breach:
3 Days Later**

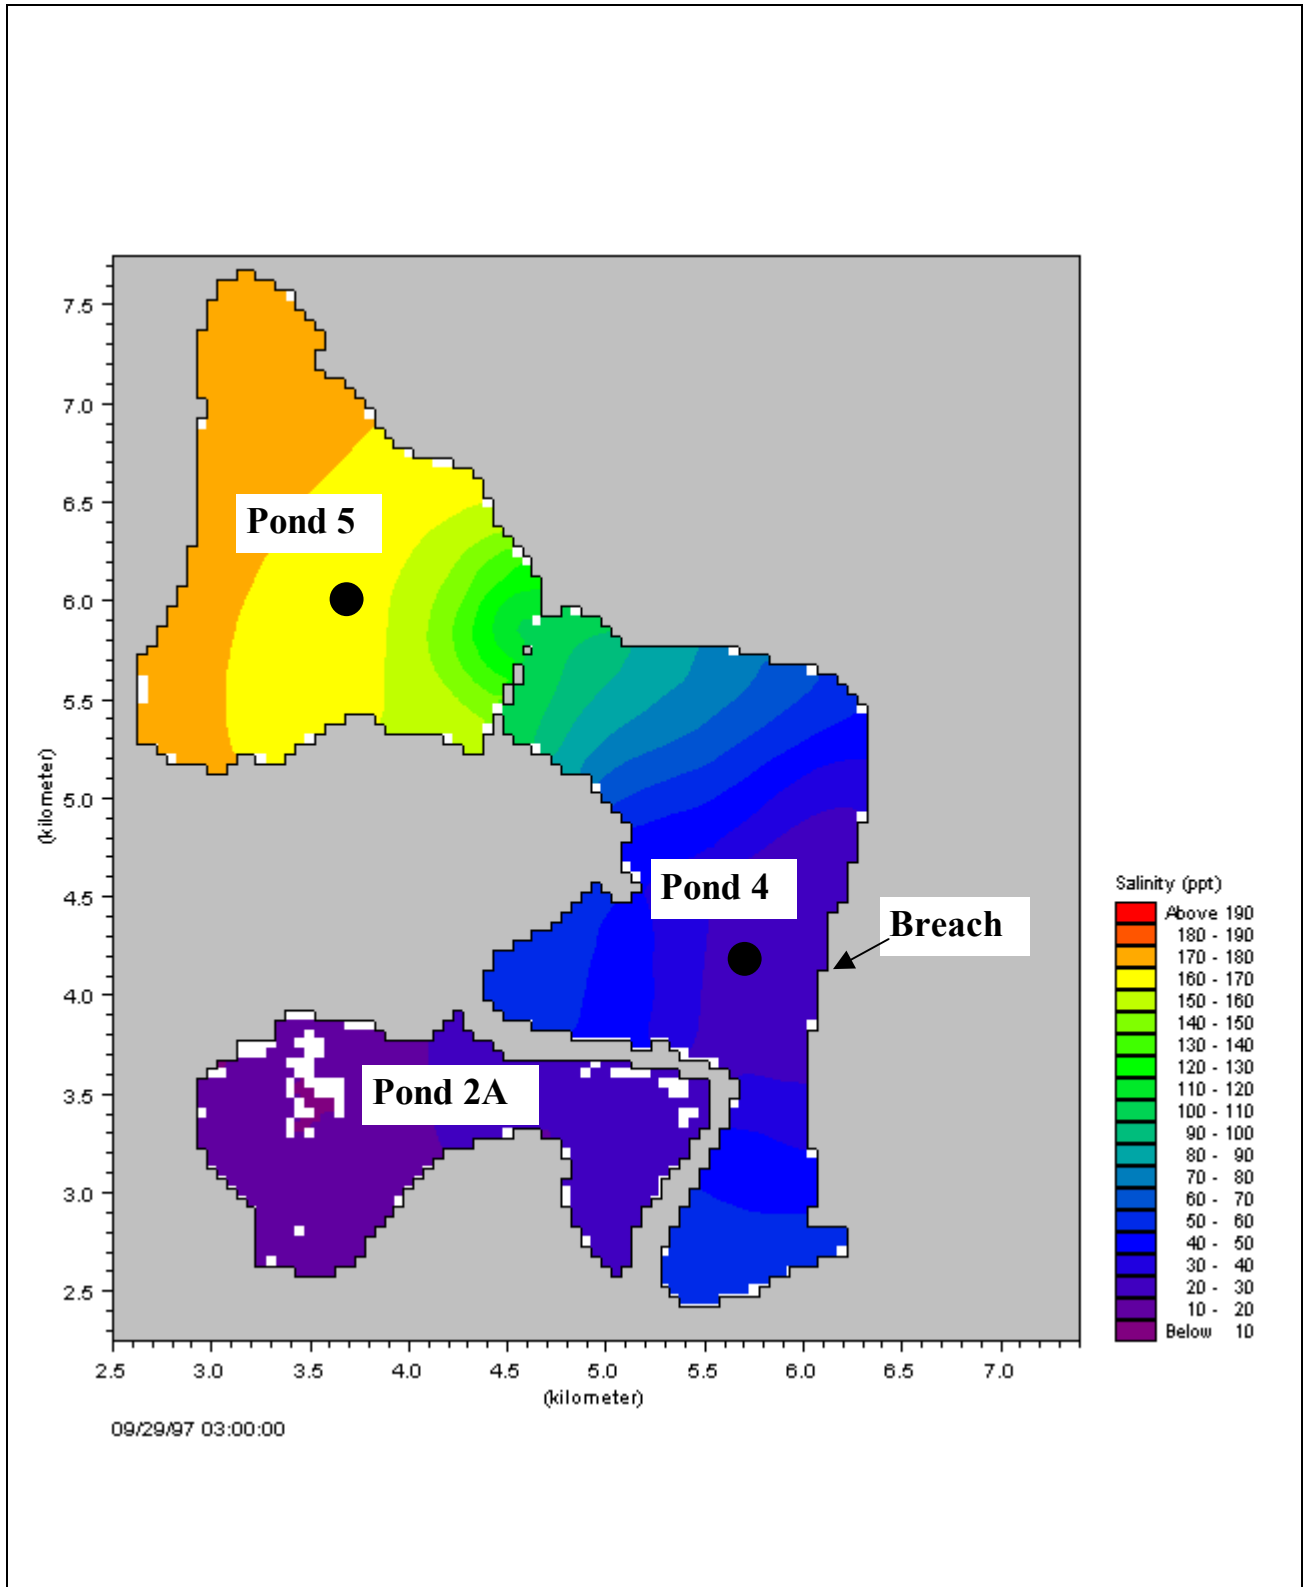
figure 8-5

Notes: High Tide

**Salinity Post Pond 4 Breach:
1 Week Later**

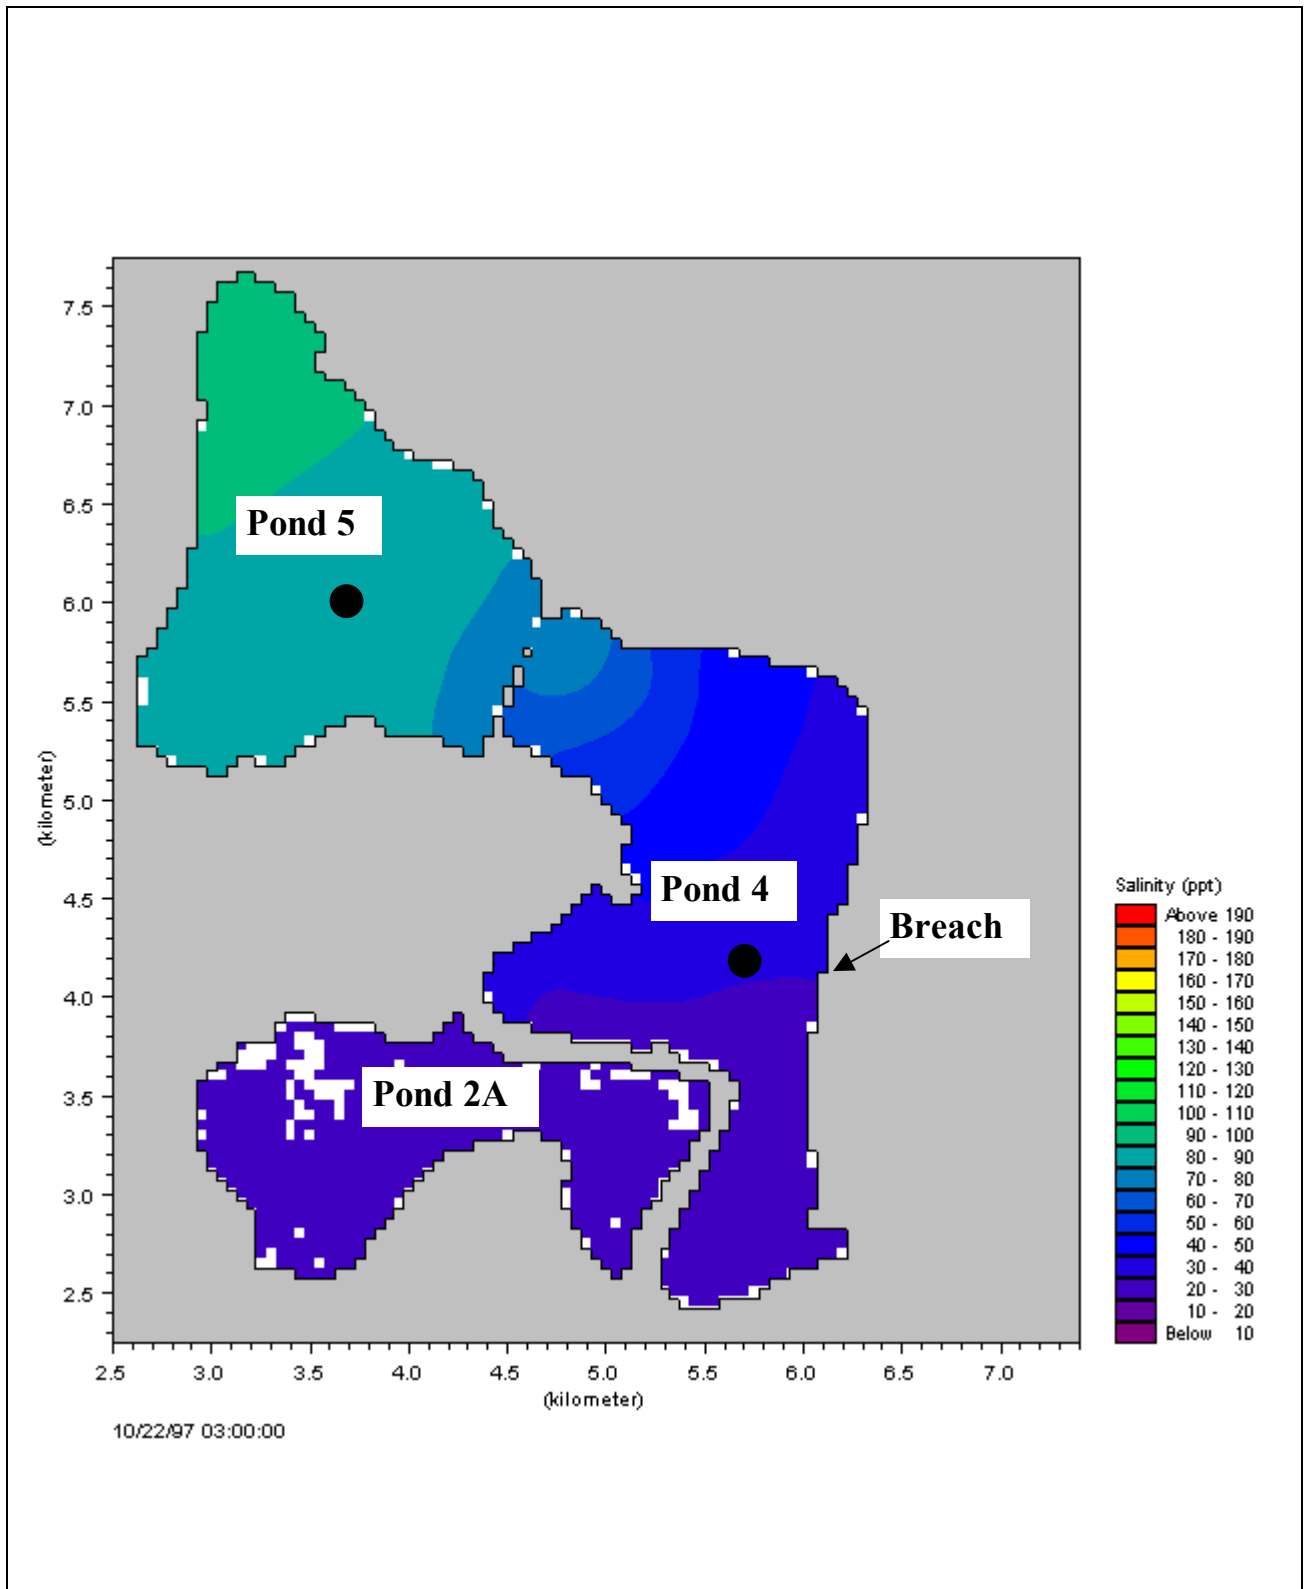
figure 8-6

Notes: Incoming Tide

**Salinity Post Pond 4 Breach:
1 Month Later**

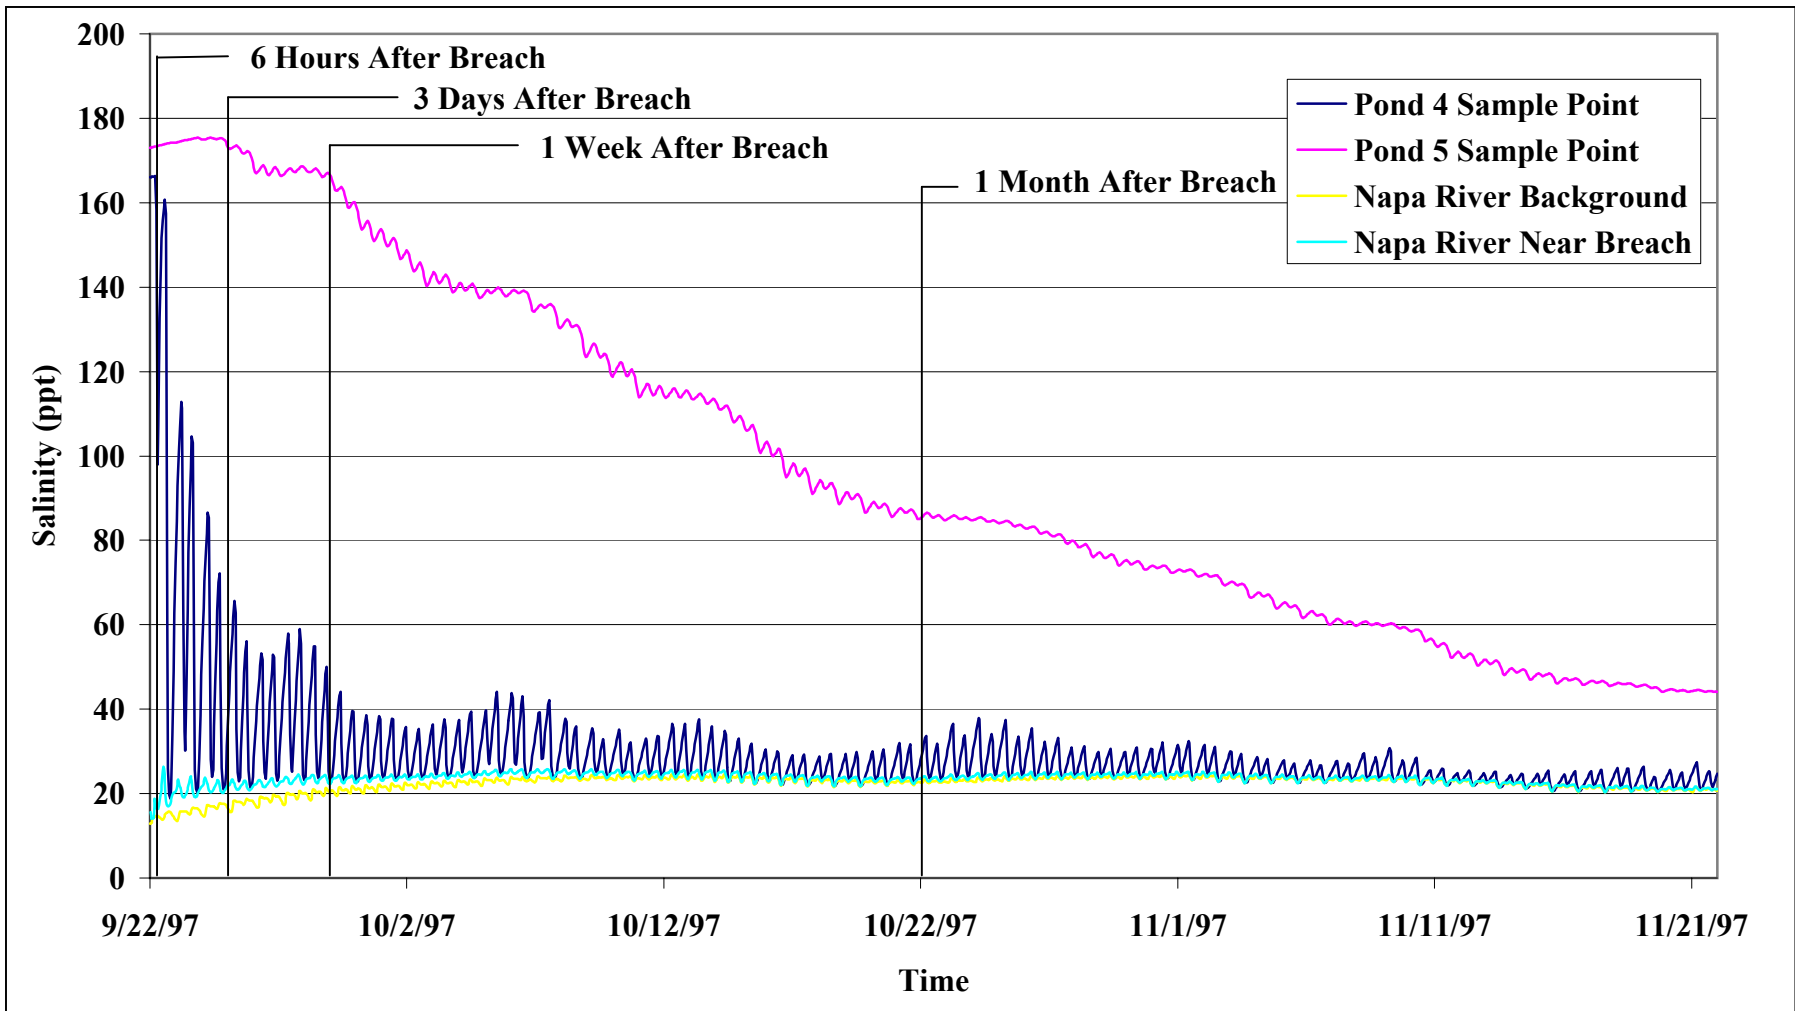
figure 8-7

Notes: Pond 4 was breached on 9/22/1997 at 03:00 during the simulation
 Source: P4BreachSalinityWSE.xls

Napa River and Pond Salinity Post Pond 4 Breach

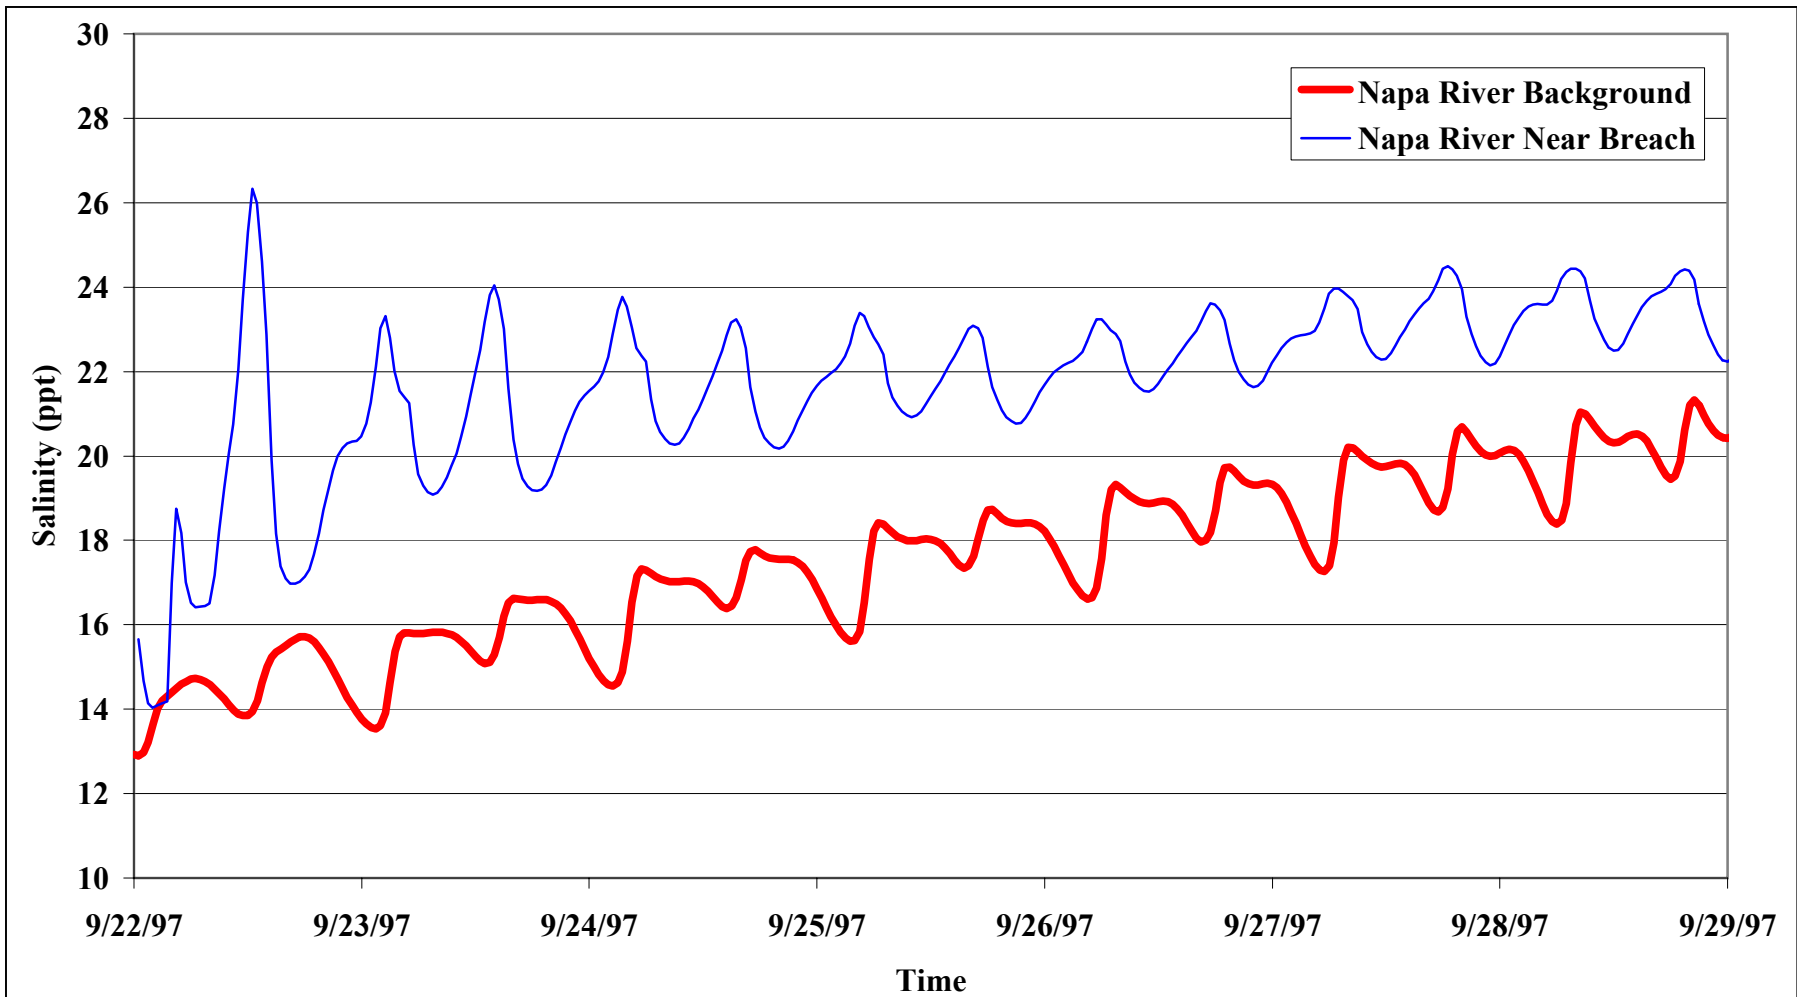
figure 8-8

Notes: Pond 4 was breached on 9/22/1997 at 03:00 during the simulation
 Source: P4BreachSalinityWSE.xls

Napa River Salinity Post Pond 4 Breach

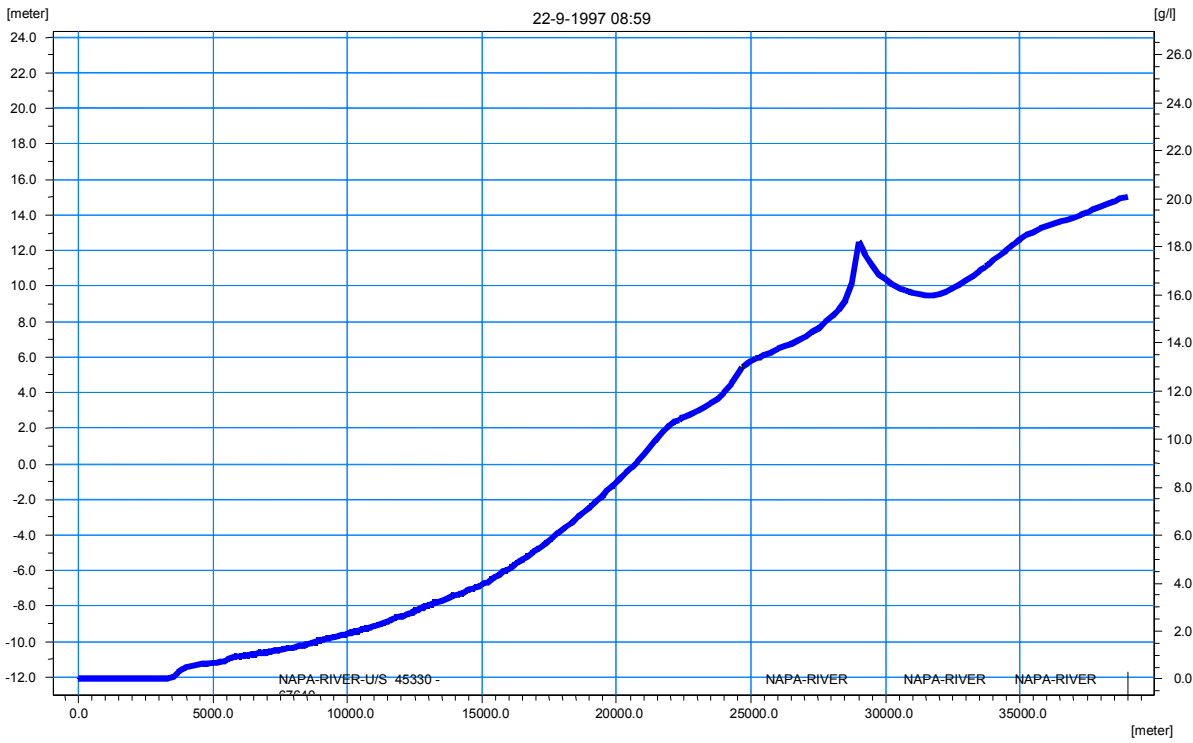
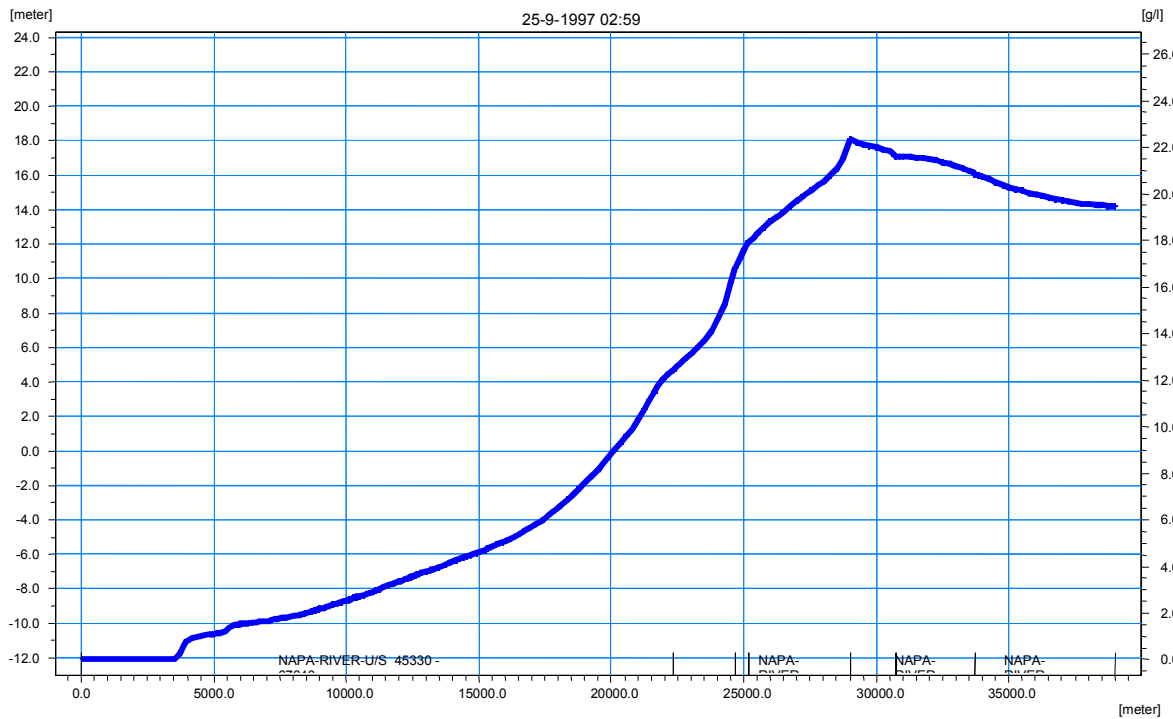
figure 8-9

Pond 4 Levee Breach – Salinity Profile in Napa River

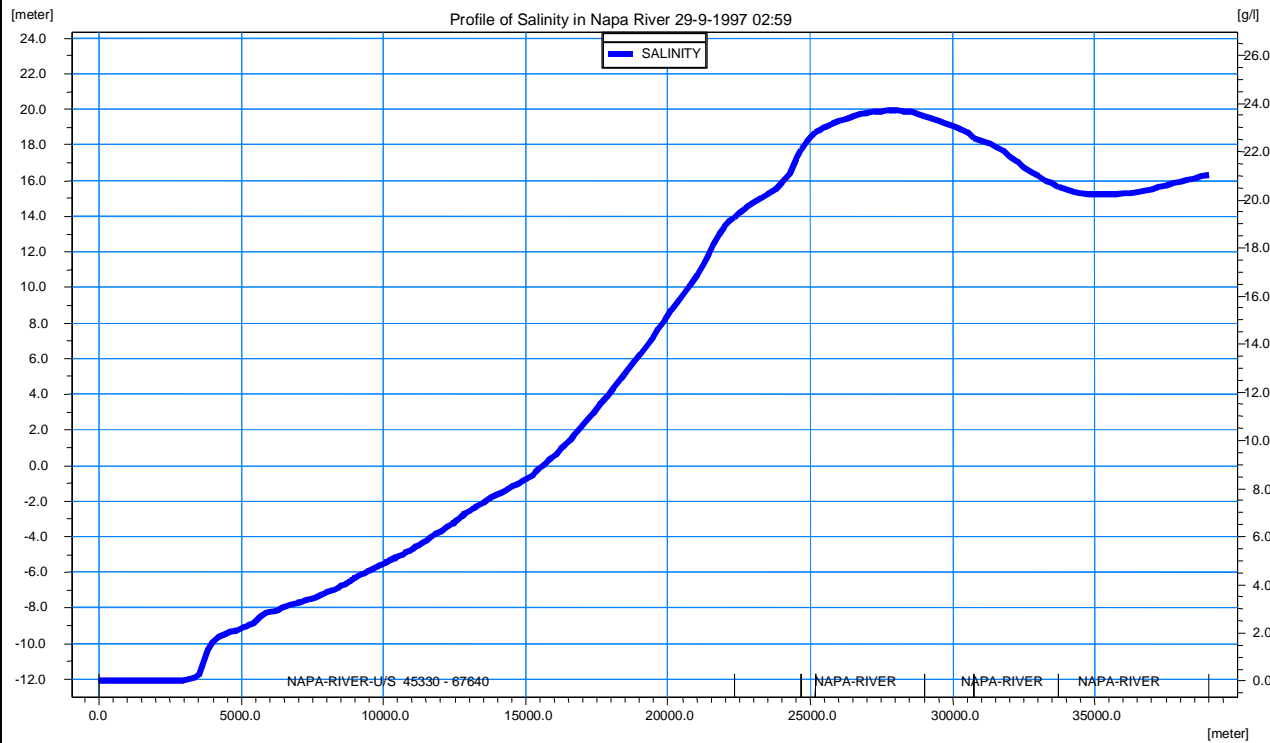
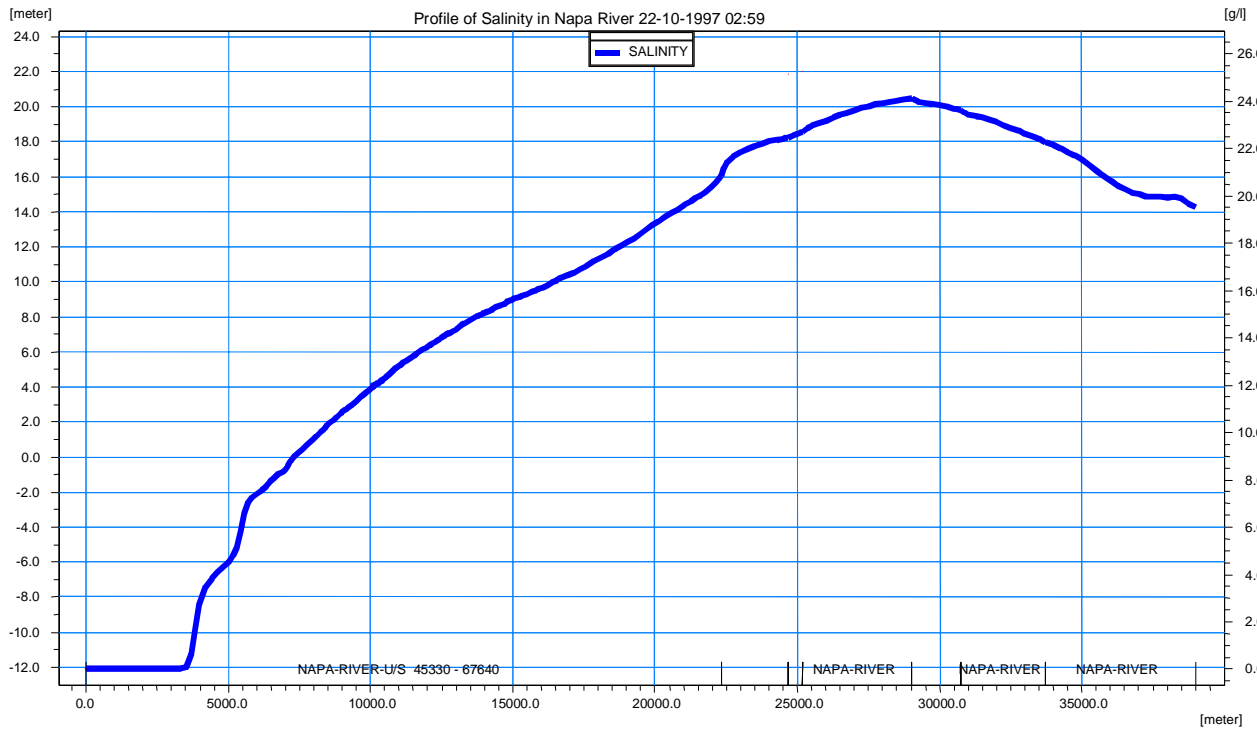
figure 8-10
Pond 4 Levee Breach – Salinity Profile in Napa River
 #1174-8
