Initial Biophysical Changes after Breaching a Salt Pond Levee: Final Report on Napa-Sonoma Wildlife Area Pond 3 Breach

Initial biophysical changes after breaching a salt pond levee: final report on Napa-Sonoma Wildlife Area Pond 3 breach

Prepared for:
California State Coastal Conservancy
1330 Broadway, 11th Floor
Oakland, CA 95612

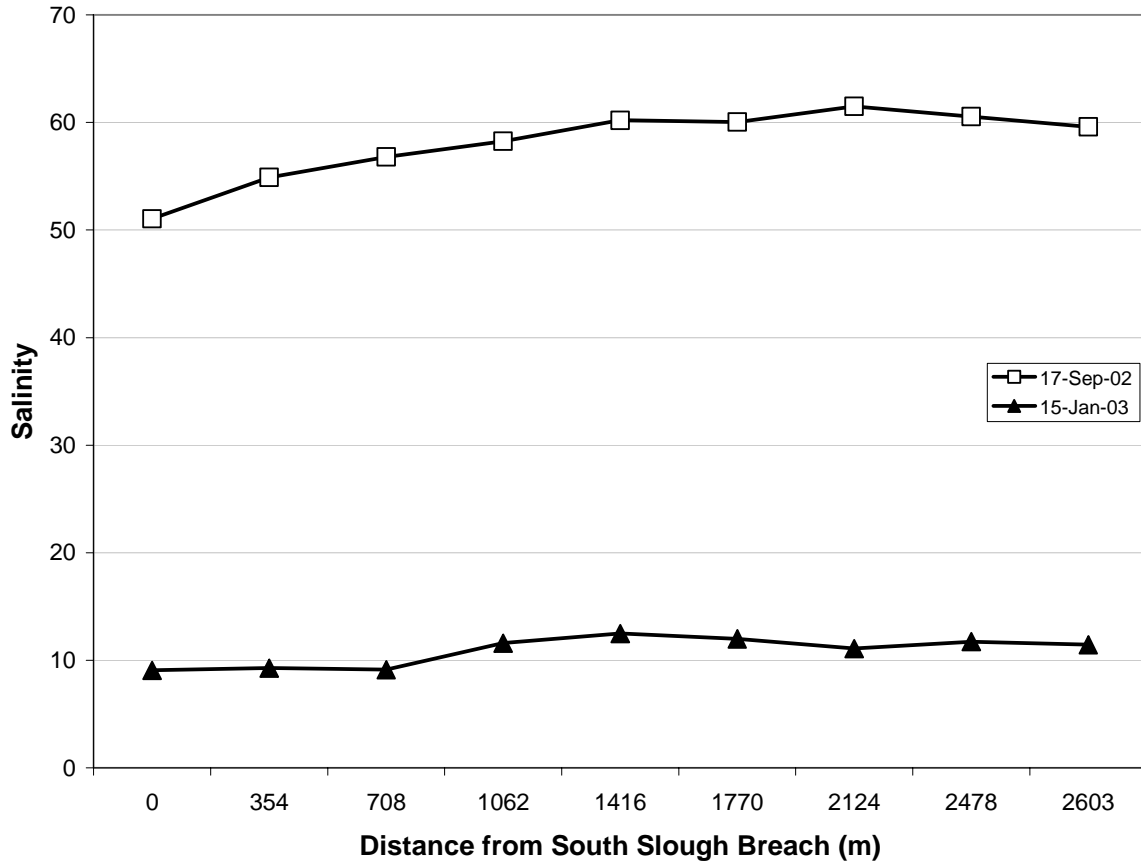
Figure 3. Between-breach salinity transects in Pond 3 one month post-breach and one month post-breach widening. Measurement starts at the South Slough breach and ends at the Dutchman’s Slough breach.

Between-breach transects in Pond 3 for salinity differed before and after the widening of the SS breach (Fig. 3). In September, we recorded a large gradient with the lowest salinity of about 50 ppt near the SS breach that increased to over 60 ppt in the southeast corner near the Dutchman Slough breach. In January, cross-pond salinity levels and gradient were greatly reduced, with salinities near the SS breach about 10 ppt and about 15 ppt near the middle of the transect. Differences between surface and bottom salinities were minor for both transect periods.

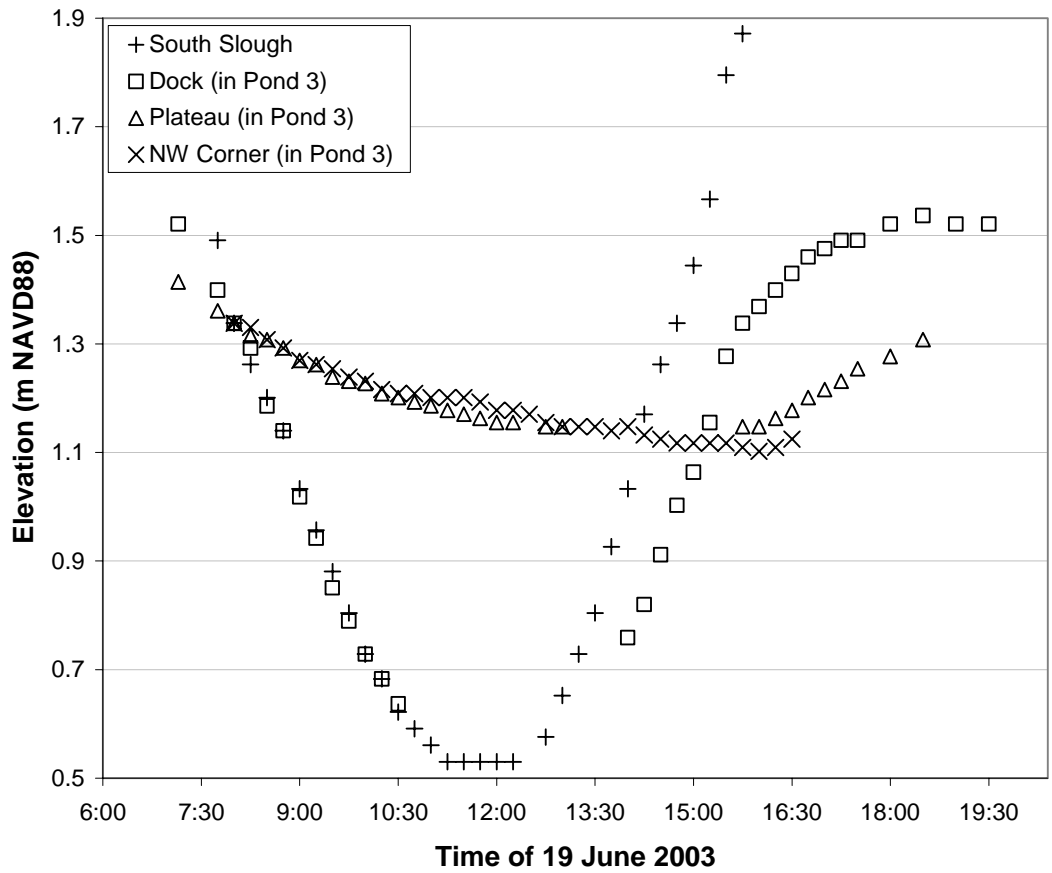
Figure 4. Water surface elevation for most of one tide in June 2003. Data gaps represent periods when the tide level fell below the minimum staff gauge reading.

Diurnal wind-driven variations were about 10 cm prior to the storm on 13 December 2002. Immediately following the storm, water level fluctuations in Pond 3 began to vary semi-diurnally and showed muted tidal influence (Fig. 2D). These tidal fluctuations are consistent with widening of the breach to SS at this time and increased tidal exchange between Pond 3 and SS. Tidal fluctuations increased to more than 1 m near the breach and about 25 cm away from the breach by June 2003 (Fig. 4). The tide range (MLLW to MHHW) at nearby Mare Island Naval Shipyard was 1.8 m (<http://co-ops.nos.noaa.gov>).

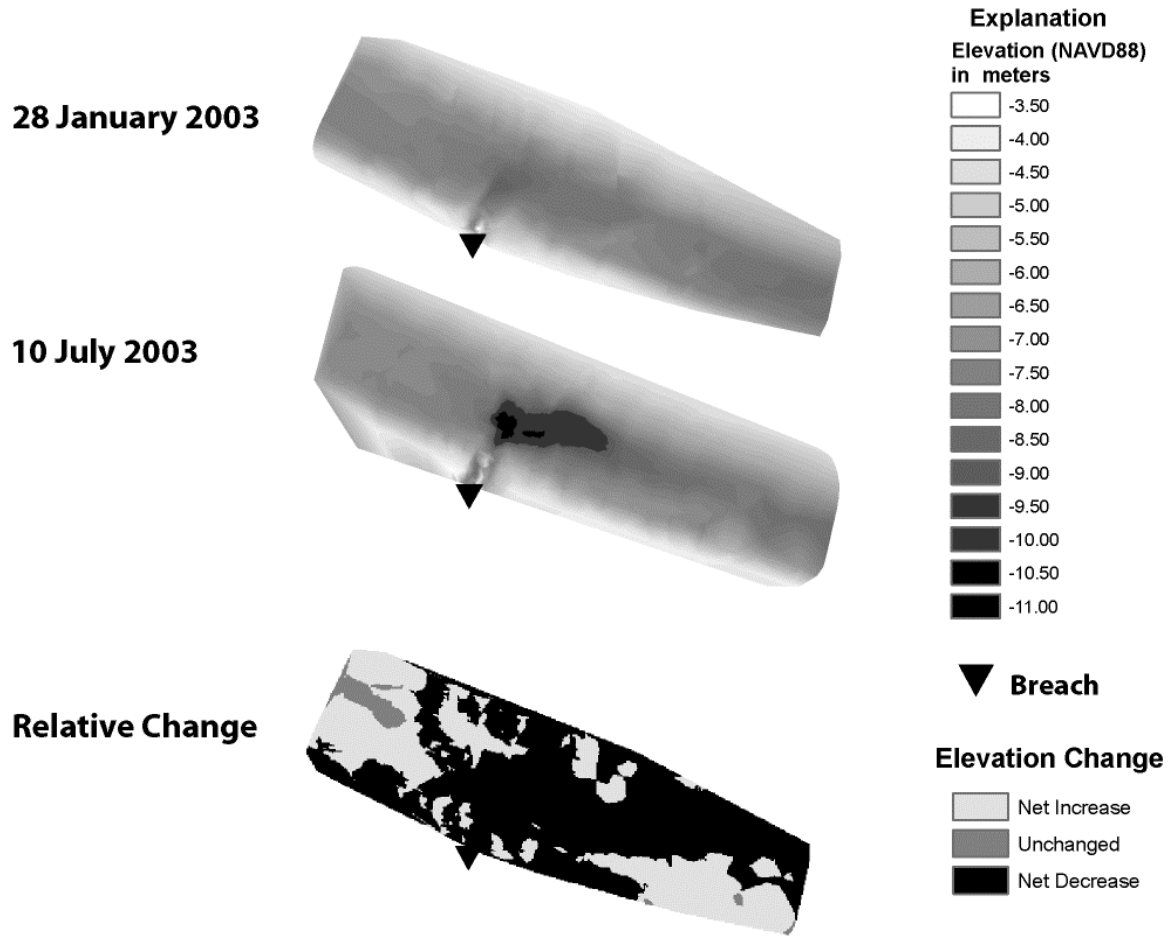
Figure 6. Change in SS bathymetry between January and July 2003. About 1,100 m³ of sediment was scoured from SS in nearly 6 months.

Flow in SS seaward of the breach increased in response to the pond tidal prism. These fast, turbulent flows scoured the channel bed creating a hole in SS immediately in front of the breach

that, in July 2003, was a maximum of 8 m deep and 45 m long (Fig. 6). This scoured hole was about 4 m deeper than the original slough bottom. Between January and July 2003, 1,100 m³ of sediment was lost from the SS bed near the breach. No erosion of the adjacent marsh or levee was observed.

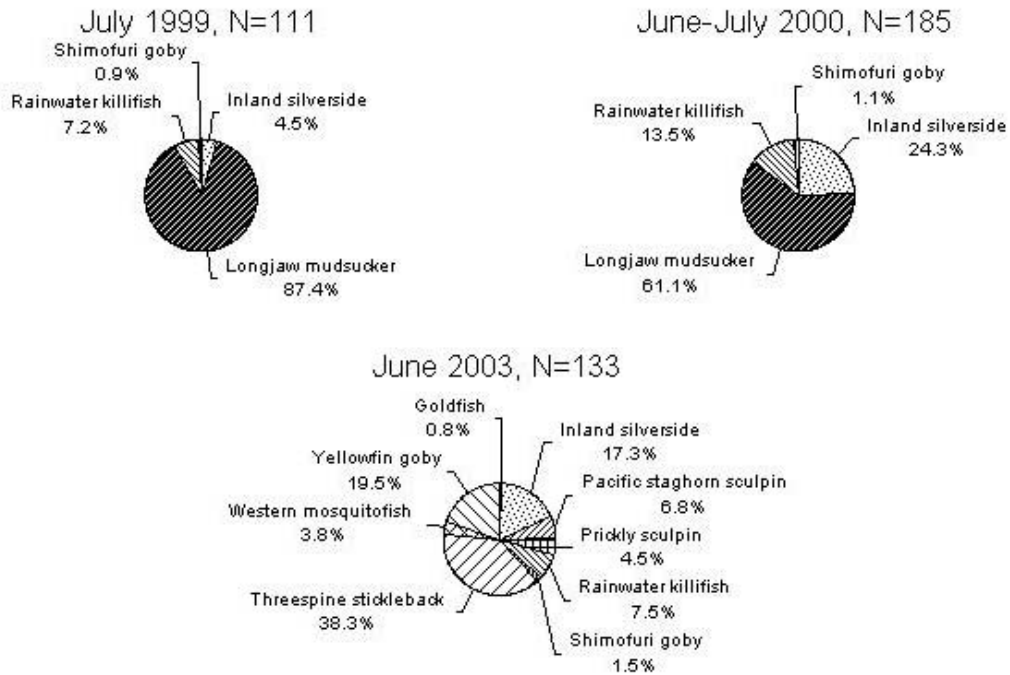
Figure 8. Percent composition of fish caught with bag seines in Pond 3 in the Napa-Sonoma Marshes, 1999 – 2000 and 2003. The SS breach occurred in late summer 2002. July 1999 and June-July 2000 are provided as pre-breach summer comparisons to June 2003.

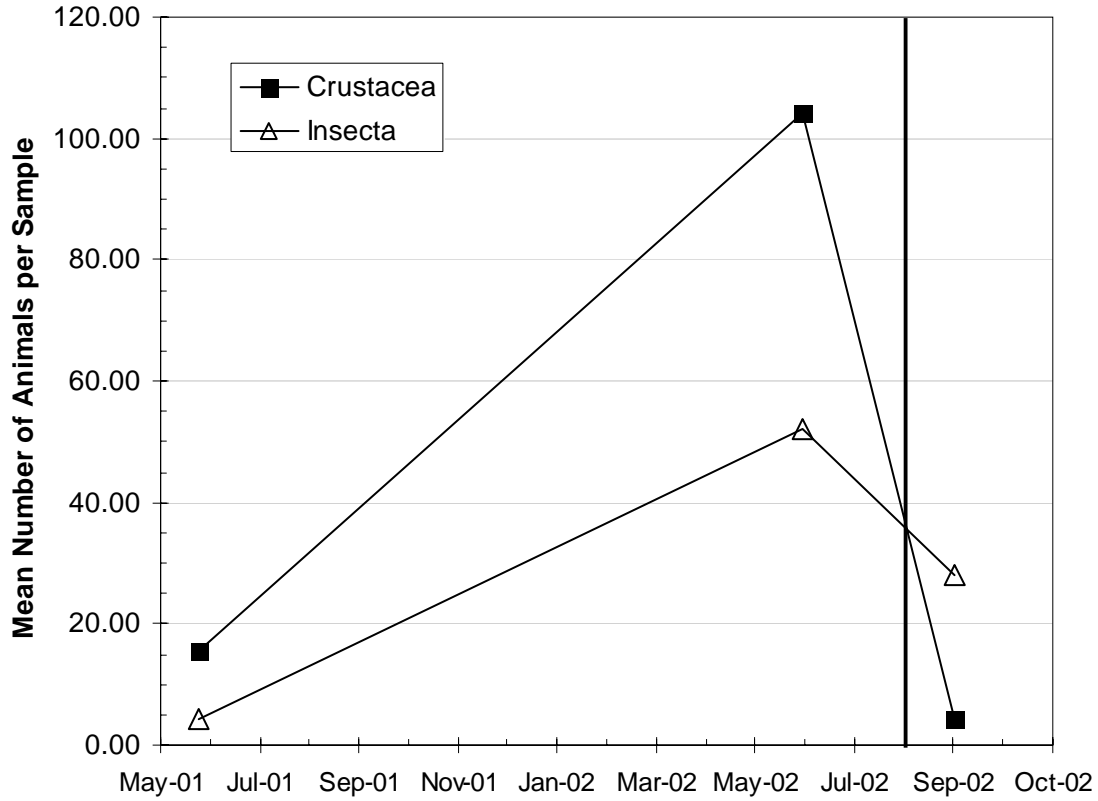
Figure 10. Pond 4 invertebrate composition. Vertical line marks the initial breaching event in August 2002.

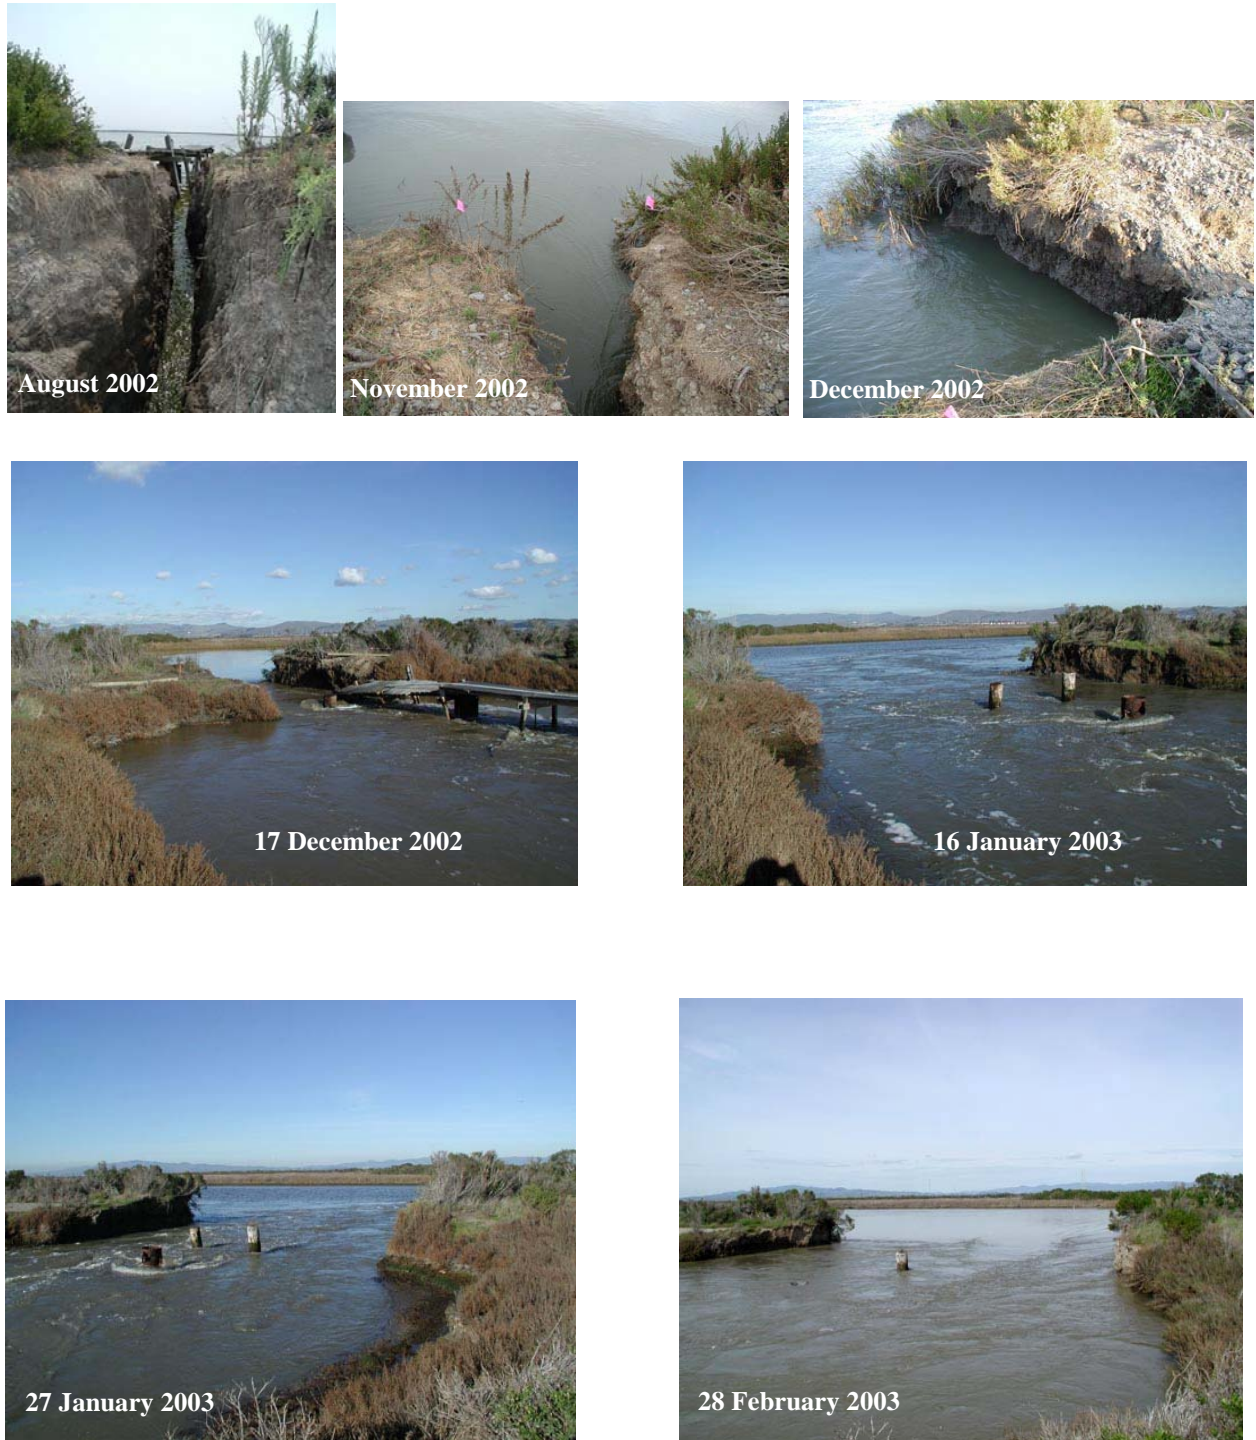
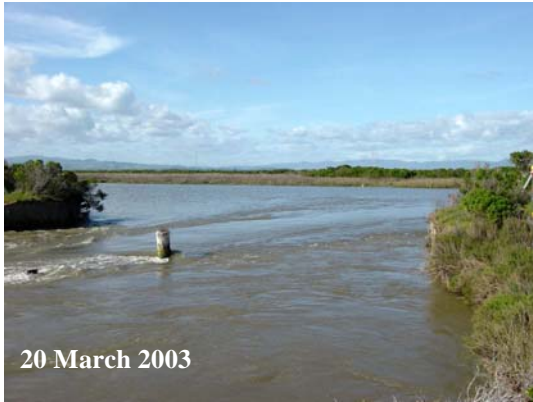
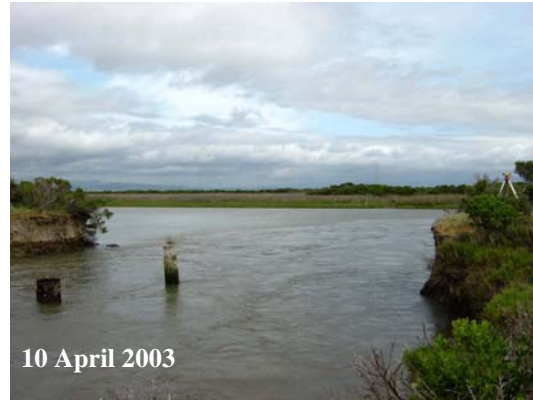
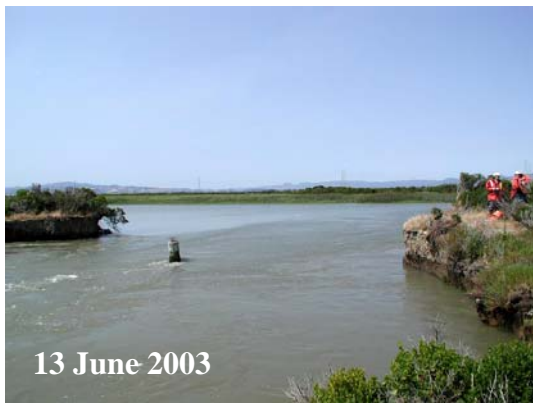
South Slough Breach

Figure 12. Images showing the sequence of changes in the South Slough breach, August 2002 – June 2003.

Figure 12 (continued). Images showing the sequence of changes in the South Slough breach, August 2002 – June 2003.

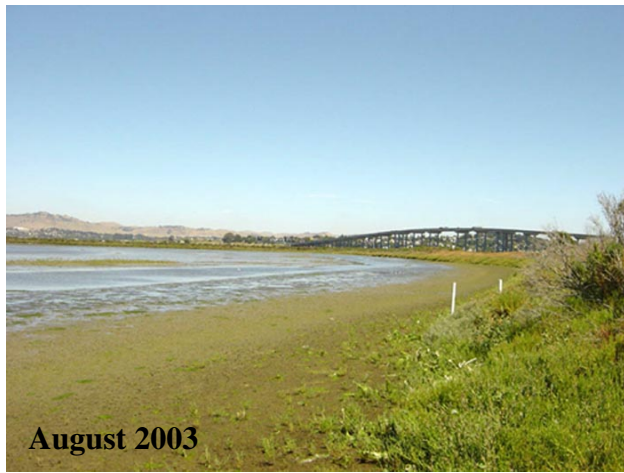
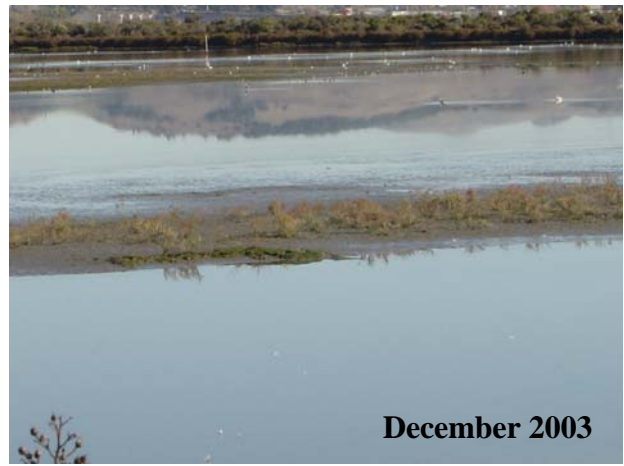
Figure 13. Initial vegetation growth in Pond 3, August – December 2003.

The most important determinant for colonization of marsh plants in Pond 3 is surface elevation of the sediments (Simenstad & Thom 1996; Cornu & Sadro 2002, Williams & Orr 2002). Mean elevation of the bottom of Pond 3 is about 1.2 m NAVD88 (Towill, Inc. 2001 survey), which corresponds to local mean low water (MLW; 1.20 m elevation at Mare Island Causeway, http://coops.nos.noaa.gov/epoch_datum_check.shtml?stnid=9415218). This is just below the average elevation of Napa Pond 2A (elevation = 1.6 m), a neighboring salt pond in the same system (Williams & Orr 2002). Pond 2A was naturally restored to greater than 50 percent salt marsh vegetation cover within three years of a levee breach. MLW is generally recognized to be below the minimum elevation for marsh colonization (Williams & Orr 2002), whereas the transition from mud flat to low marsh usually occurs at mean tide level (MTL, Orr et al. 2003). Generally, salt marsh plants are concentrated in the range from MHW to MHHW. Around the Napa Ponds, this ranges from 1.87 m (MTL) to 2.53 m (MHW) to 2.70 m (MHHW), suggesting that high points of the pond bottom that are near MTL may now be suitable for colonization. However, Crooks et al. (2002) suggested that poorly drained regions, even at elevations suitable for marsh plant colonization, will not be colonized. This is mostly a consequence of waterlogged sediments, which reduces required photosynthetic gas exchange. In fact, the first noticeable vegetation in Pond 3 was the green alga *Enteromorpha* spp. when it appeared in February 2003. This alga is associated with waterlogged sediments and reduced colonization of the early colonizing halophyte *Salicornia* spp. in England (Reading et al. 2000 as reported in Crooks et al. 2002). Pickleweed (*Salicornia virginica*) was observed in August 2003 (Fig. 13) to colonize some of the higher points and edges of Pond 3. However, the mean pond elevation must increase through sedimentation, and the drainage must improve before a restored salt marsh can flourish.
