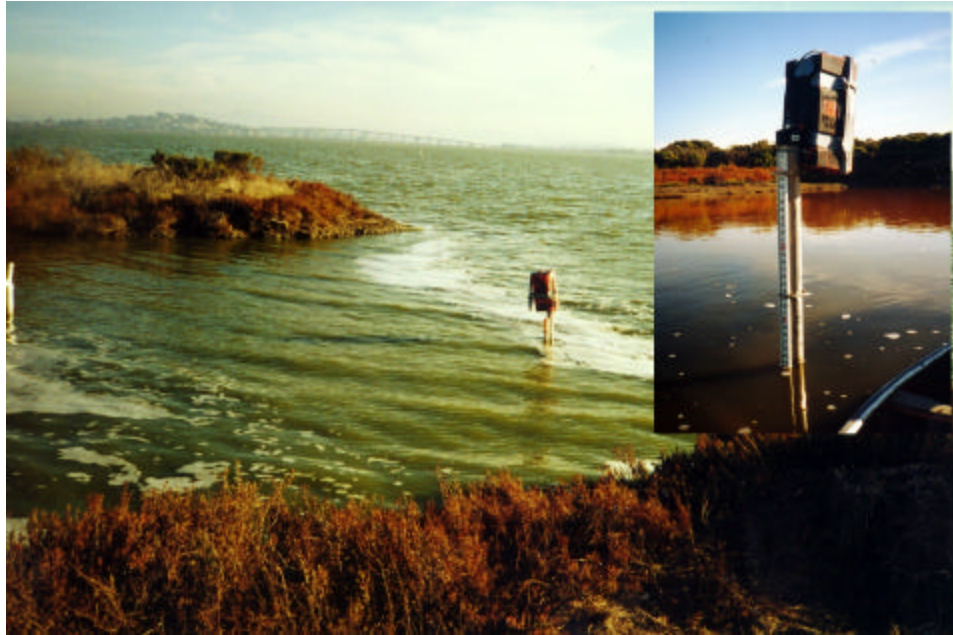
Figure 5. Platform installation at the inlet to Siphon 3 in Pond 3.

*A conductivity probe to measure salinity and a pressure transducer to measure water surface elevation were attached to this staff gauge and connected to a data logger shown in the insert.*

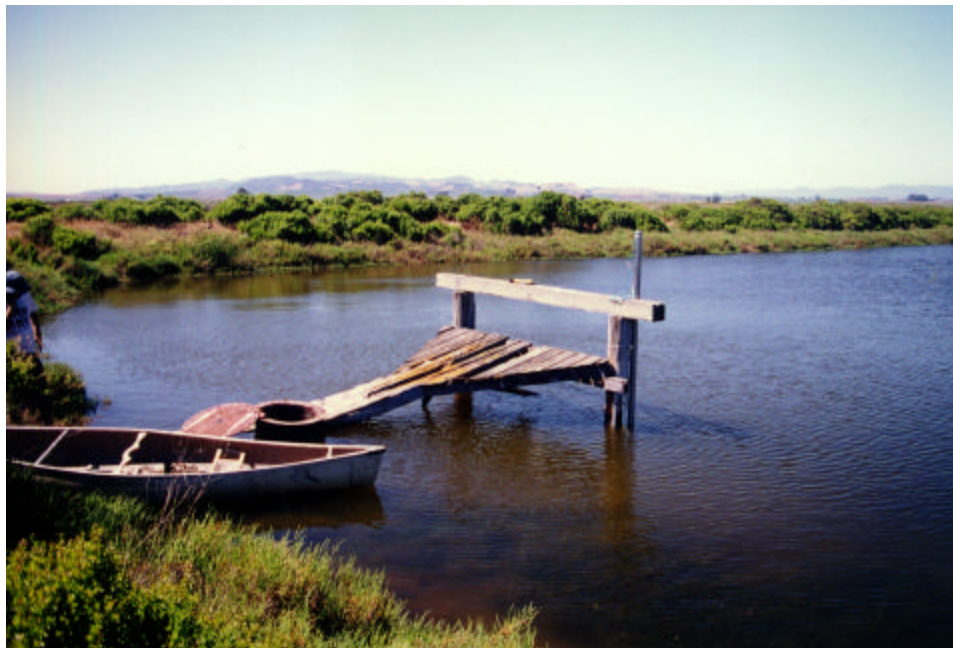
Figure 6. Access platform to upstream canal side of Siphon 5.

*Notice the access shaft to the siphon just behind the canoe. Instrumentation was fixed to these platforms where possible.*
