Figure 3-1
Existing Conditions

01396.01 Feas Study

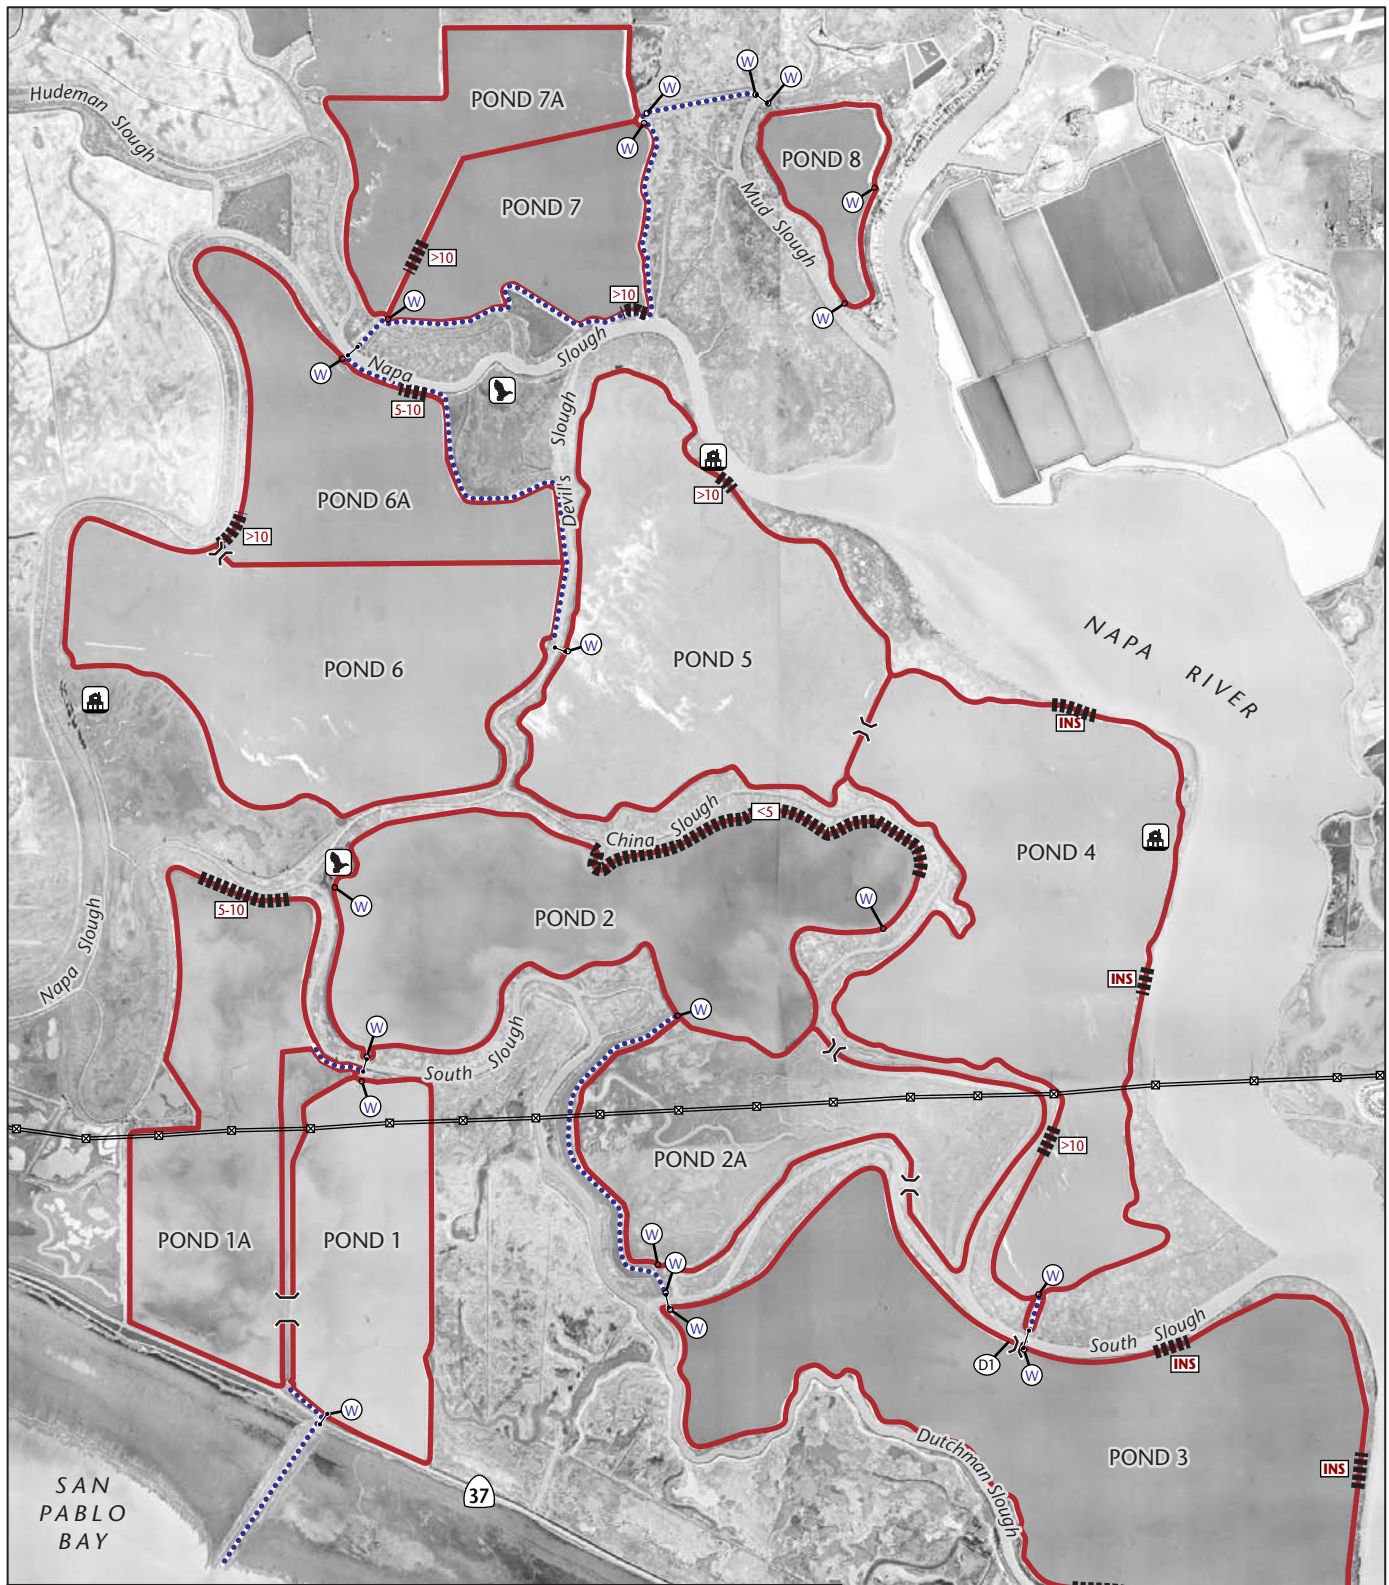
Water Control Structure		Breaches Imminent (<5 Years)
	Canal		Breaches Soon (5-10 Years)
	Power Lines		Breaches Long-Term (>10 Years)
	Siphon		Inspect Regularly
	Levees		
	Former Ranch Site		
	Duck Club		
	Existing Breaches		
	Ditch
